Building & Pest Inspection Report

Type of Report: Building & Pest Inspection

Address of Property: Sample Report

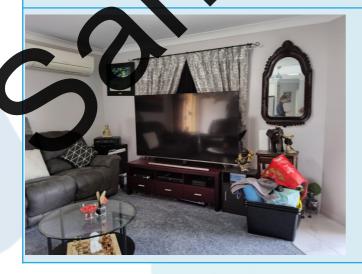
Furniture restricted the inspection of the window and window frame

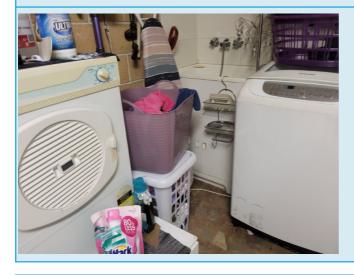
The cabinet door was blocked at the time of inspection

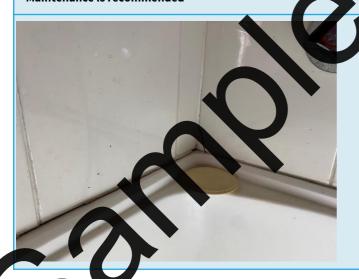
A broken wall tile was found on the splashback. Maintenance is recommended

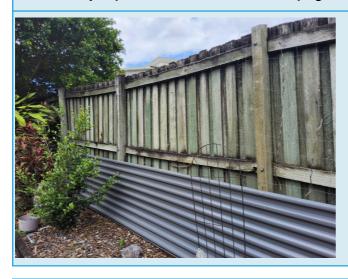
The timber fence is leaning in some areas. Contact body corporate for details on maintenance program

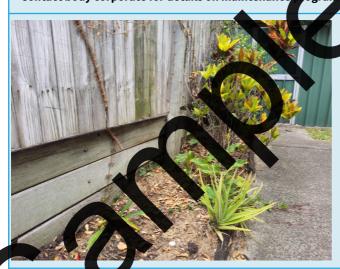
The timber retaining wall is leaning in some areas. Contact body corporate for details on maintenance

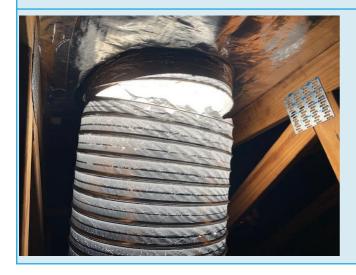
The skylight tube has deteriorated and split. Maintenance is recommended

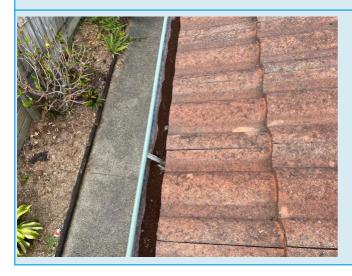
Sand/mud in the gutters can lead to premature rusting. Maintenance is recommended

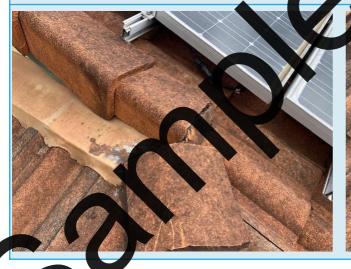
The ridge cap pointing has cracked in some areas.

Contact body corporate for details on maintenance program

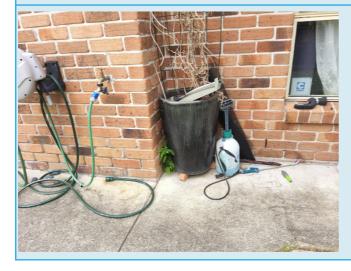
Stored items against the building restricted the inspection and provides conditions for undetected termite entry. Keep a clear inspection zone around the perimeter of the building

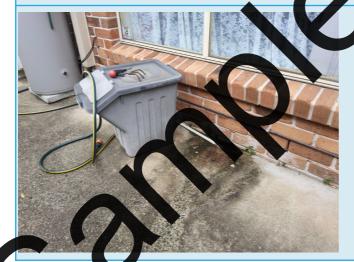
The air-conditioning unit is inadequately drained providing conditions conducive to timber pest activity. Redirect to the nearest downpipe as soon as possible

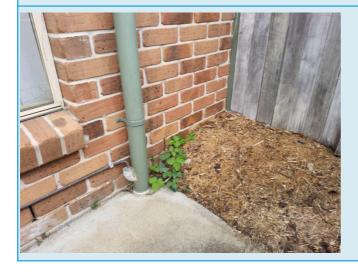
Garden mulch against the building provides conditions conducive to timber pest activity. Keep a clear inspection zone around the perimeter of the building
