Building & Pest Inspection Report

Type of Report: Building & Pest Inspection

Address of Property: Sample Report

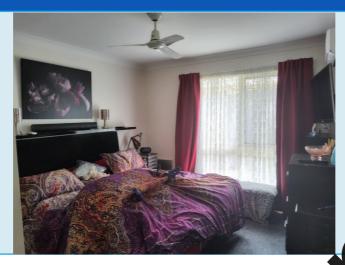
8.1. Bedroom 1

Condition Visually Fine	General Advice/Minor Defect	Major Defect	Unable to Inspect Due to Aucess	Not Applicable
Floor	₫				
Walls	₫				
Ceilings	₫				
Doors	₫				
Windows	₫	7			
Robes	ď				
Smoke Detectors	₫	To

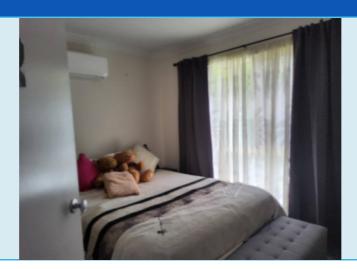
8.2. Bedroom 2

Condition Visually Fine	General Advice/Minor Defect	Major Defect	Unable to Ir spect Due to Access	Not Applicable
Floor	₫				
Walls	₫				
Ceilings	₫				
Doors	₫				
Windows	₫				
Robes	₫				
Smoke Detectors	Ø

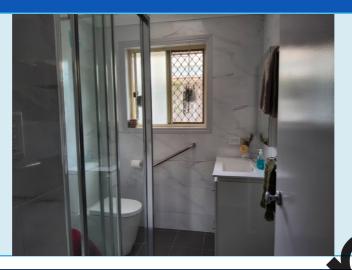
9.1. Bathroom 1

Condition Visually Fine	General Advice/Minor Defect	Major Defect	Unable to Inspect Duc to Alcess	Not Applicable
Floor	₫				
Walls	₫				
Ceilings	₫				
Windows	₫				
Doors	₫	7			
Shower Recess	đ				
Shower Screen	₫	T			
Shower Rose	₫ ,				
Bath					₫
Taps	V				
Cabinets	Ø				
Sealants	M				
Basins	Ø				
Toilet	₫				
Ventilation	₫

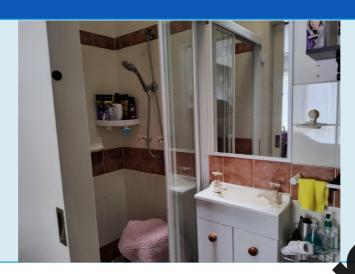
10.1. Ensuite 1

Condition Visually Fine	General Advice/Minor Defect	Major Defect	Unable to Inspect Duc to Access	Not Applicable
Floor	₫				
Walls	₫				
Ceilings	₫				
Doors					₫
Windows	₫	7			
Shower Recess	₫ •				
Shower Screen	₫	T			
Shower Rose	ď				
Bath					₫
Mixer Taps	V				
Cabinets	Ø				
Sealants	M				
Basins	Ø				
Tuilet	₫				
Ventilation	đ
